Northern NY Agricultural Development Program 2016-2017: Final Project Report: Photos

Quantifying Long-Term Agronomic and Water Quality Impacts of Tile Drainage in Northern New York

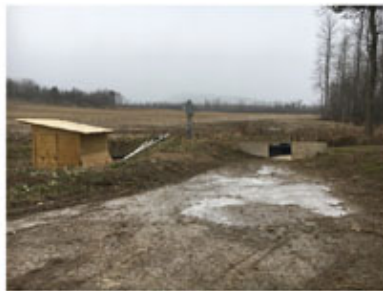
Figure 2, center. Flume for measuring surface water runoff for tile-drained field, NNYADP Tile Drainage project, 2017.

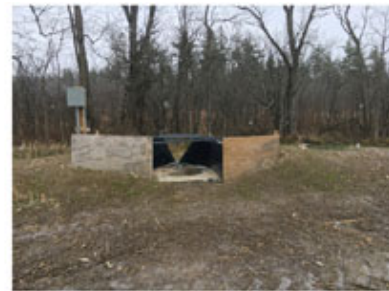
Figure 3, right. Flume for measuring surface water runoff for undrained field, NNYADP Tile Drainage project, 2017.

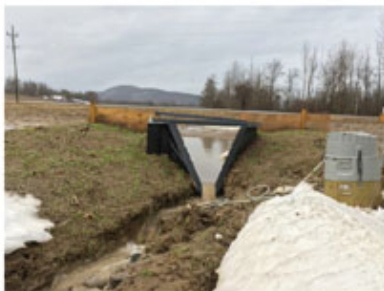
Figure 4, left: Flume capturing surface runoff during snowmelt event on 1/12/18 for undrained field, NNYADP Tile Drainage project, 2017.

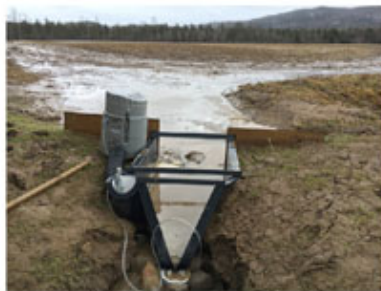
Figure 5, right. Flume capturing surface runoff during snowmelt event on 1/12/18 for tile-drained field, NNYADP Tile Drainage project, 2017.
